检 测 报 告  
TEST REPORT

报告编号 (No.) :UTS23060026R86 报告日期 (Report Date) : 2023/08/31

样品名称/Sample Name : PHC 系列连接器/PHC series connectors  
料 号/Part No. : PHC-nAWB-NK  
PHC-nAB-NK  
PHC-T-NK  
PHC-nY-NK  
PHC-nYK  
接样日期/Receiving Date : 2023/06/20  
检测项目/Test Item : TG5 机械和热张弛特性;  
TG5 Mechanical and thermal relaxation behavior

VW 75174 LV-214 2018 及客户要求; VW 75174 LV-214 2018 and customer requirements

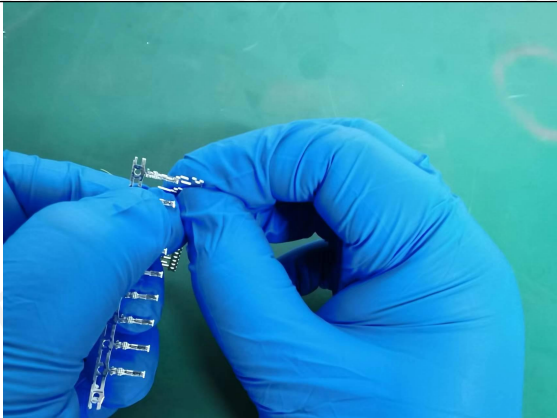
拔插 5 次; 5 times

L5.1 One half (5 pieces each) of all test batches is inserted and extracted 5 times before further loading;

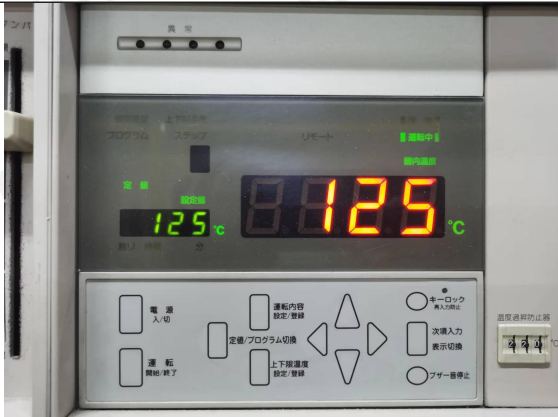
温度界面;Temperature interface

插拔力;Insertion and extraction force

拔插力试验结果 Insertion and extraction force test result
