# 检 测 报 告

报告编号 (No.) :UTS23060026R66 报告日期 (Report Date) : 2023/08/25

样品名称/Sample Name : PHC 系列连接器/PHC series connectors  
料 号/Part No. : PHC-nAWB-NK  
PHC-nAB-NK  
PHC-T-NK  
PHC-nY-NK  
PHC-nYK  
接样日期/Receiving Date : 2023/06/20  
检测项目/Test Item : TG28 锁止噪声/TG28 Locking Noise

VW 75174 LV-214 2018 及客户要求; VW 75174 LV-214 2018 and customer requirements

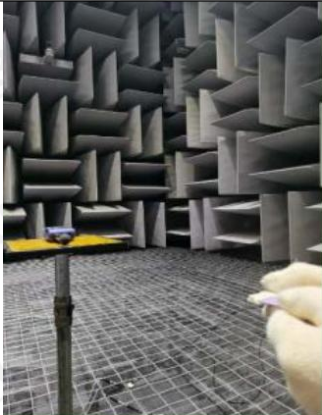
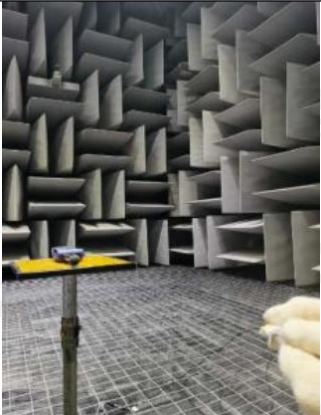
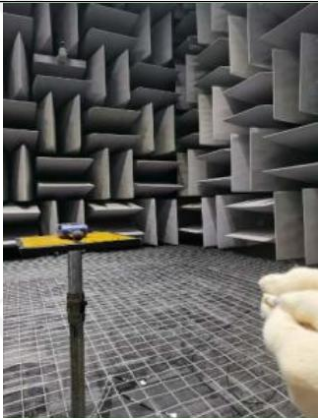
| 测试中-15pin; During test-15 pin | 测试中-8pin; During test-8pin |

| 测试中-2pin; During test-2pin | 嵌合音-15pin; Locking-15pin |

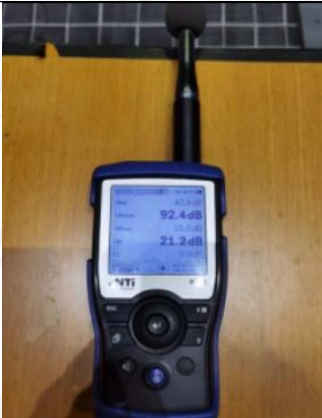
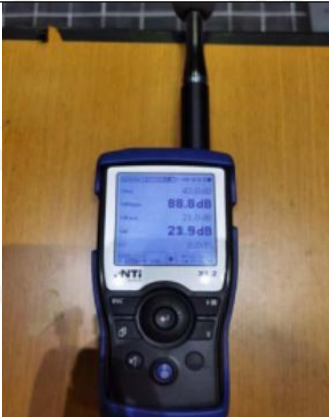
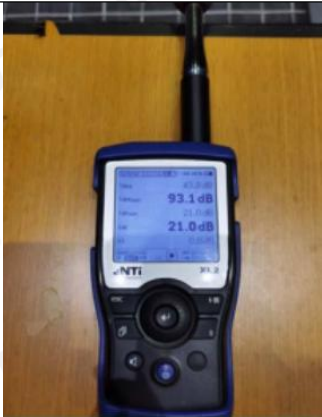
| 样品编号<br>Sample No. | | 噪音 (分贝)<br>Noise(dB) | | 信噪比<br>(dB)<br>signal-to-noise | 判定依据<br>Judgment Basis | 判定<br>Determine |
|---|---|---|---|---|---|---|
| 15pin | 1# | 21.0 | 92.4 | 12.87 | 嵌合音和周围噪音的信噪比至少为 7dB(A);<br>For this purpose, the signal-to-noise ratio between the locking noise and the ambient noise must be at least 7dB (A);<br>嵌合音至少为 $L_{Apeak} \geq 70\text{dB}$ (A) $L_{Apeak}$ 频率加权为 A 的噪声值峰值。The locking noise must be at least $L_{Apeak} \geq 70\text{dB}$ (A). $L_{Apeak}$ : peak level of the sound level with frequency weighting A. | 符合 PASS |

| 嵌合音-8pin; Locking-8pin | 嵌合音-2pin; Locking-2pin |
