# 检 测 报 告

报告编号 (No.) :UTS23060026R67 报告日期 (Report Date) : 2023/08/25

样品名称/Sample Name : PHC 系列连接器/PHC series connectors

检测项目/Test Item : TG31 公针保持力;TG31Holding force for contact pins and contact blades in plastic contact housing

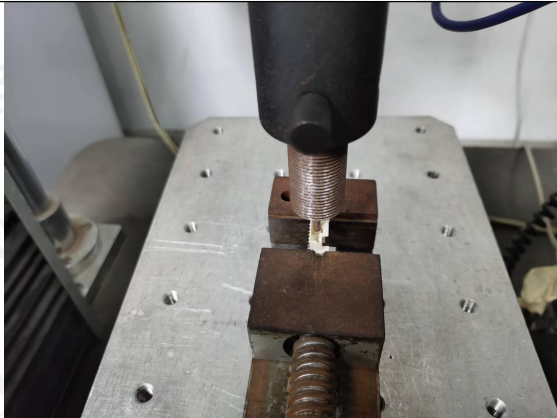
8PIN WVS 测试中; During test-8PIN WVS

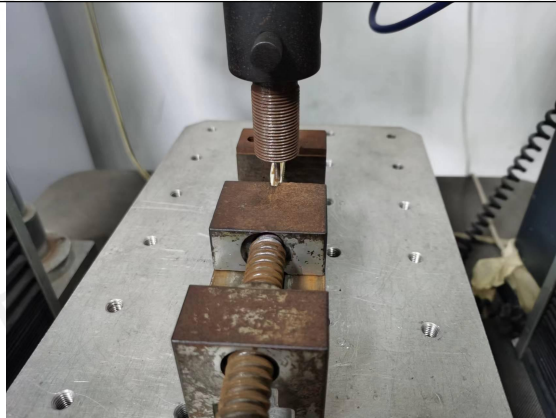
15PIN WRS 测试中; During test-15PIN WRS

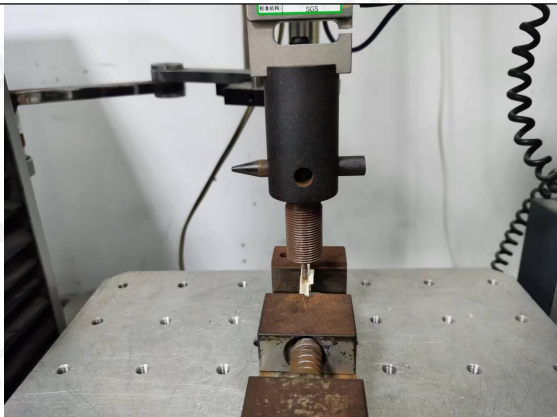
15PIN WVS 测试中; During test-15PIN WVS
