TEST REPORT

Report No.: UTS25120146M17E

Sample Name : PFZn8-C (Yellow galvanized)

Test Item : Pb、Cd、Hg、Cr (VI)、PBBs、PBDEs & HBCDD

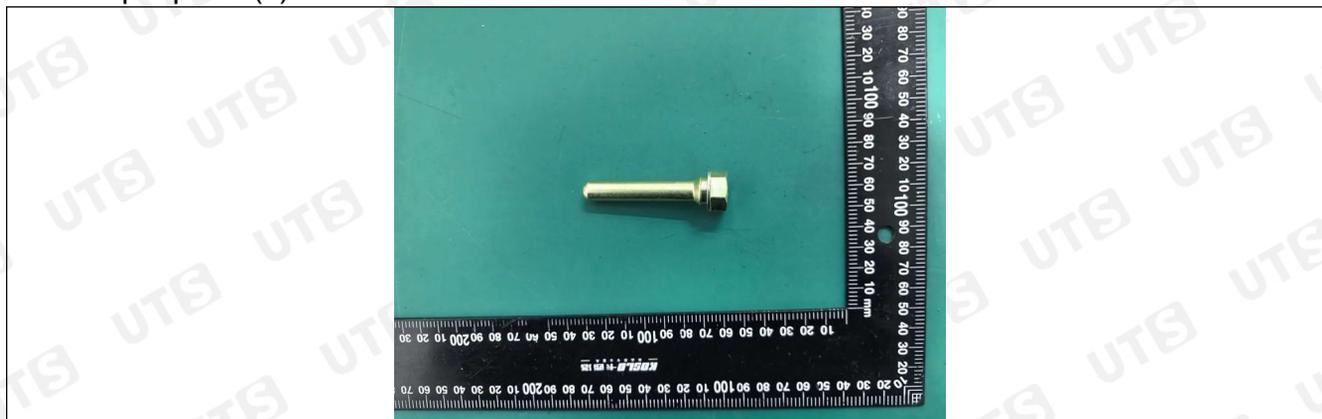
5. Sample photo(s)

Description : Coating
